North Mesa Picnic Grounds

**280 N Mesa Rd
Los Alamos, NM 87544**

Accessibility Evaluation

***Inspection Date: 11/03/2021
Inspector: Jay Rhodes***

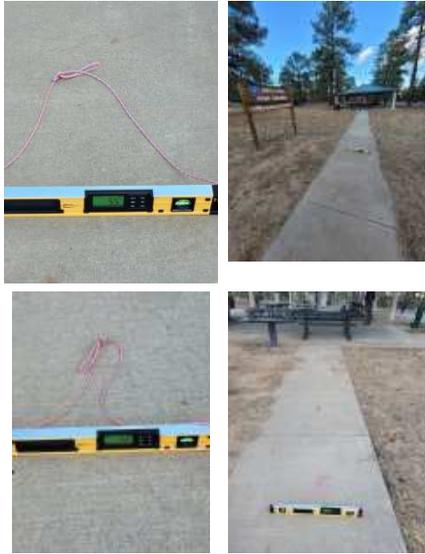
Finding Number	Area Description	Lat/Long	Finding	As Built	Recommendation	Citation	Photos	Figure
4	Exterior: Exterior Accessible Route	[35.89615, -106.2934]	The accessible route of travel on the accessible route contains cross slopes greater than 2%. Cross slopes shall not exceed one unit vertical in 48 units horizontal (2-percent slope).	Cross slopes of 5.5% by disc golf sign near group Pavilion, and 2.3% in front of Pavilion	Correct or repair cross slope along AR to max 2.08%.	2015 ABAAS Section: 403.3 2010 ADAS Section: 403.3 1991 ADAS Section: 4.3.7

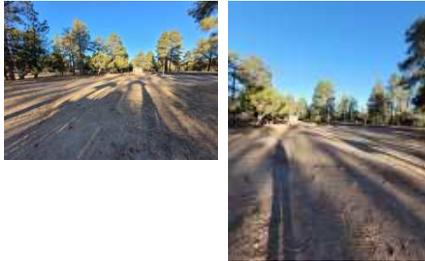
5	Park Site: Sports Fields/Courts	[35.89615, -106.2934]	At least one accessible route shall connect accessible buildings, accessible facilities, accessible elements, and accessible spaces that are on the same site. For areas of sport activity, an accessible route is required to connect to the boundary of each area of sport activity. The size of an area of sport activity includes only the space needed to play. Where multiple sports fields or courts are provided, an accessible route is required to each field or area of sport activity.	Lacks AR to sand volleyball court	Provide an accessible route to each element within the site.	2010 ADAS Section: 206.2.2, 206.2

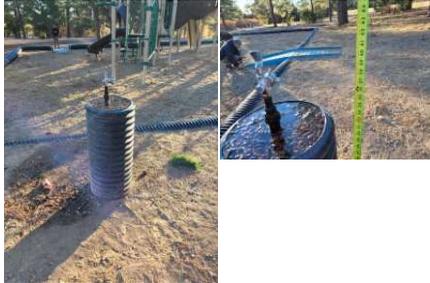
10	Park Site: Park Elements	[35.89615, -106.2934]	The drinking fountain has multiple violations. Drinking fountains must be on an accessible route that provides a 30 inch by 48 inch clear floor space centered on the low unit, allowing a forward approach. Spout outlets shall be 36 inches maximum above the finish floor or ground. Spout outlets of drinking fountains for standing persons shall be 38 inches minimum and 43 inches maximum above the finish floor or ground. The spout shall be located 15 inches minimum from the vertical support and 5 inches maximum from the front edge of the unit, including bumpers. The spout shall provide a flow of water 4 inches high minimum and shall be located 5 inches maximum from the front of the unit. The angle of the water stream shall be measured horizontally relative to the front face of the unit. Where spouts are located less than 3 inches of the front of the unit, the angle of the water stream shall be 30 degrees maximum. Where spouts are located between 3 inches and 5 inches maximum from the front of the unit, the angle of the water stream shall be 15 degrees maximum. Operable parts shall comply with applicable standards.	Drinking fountain at playground fails - not of accessible design, lacks CGS, lacks AR, not on compliant surface	Replace drinking fountain with a hi-lo bowl fountain.	2015 ABAAS Section: 403.5.1 , 602.1 2010 ADAS Section: 403.5.1, 602.1 1991 ADAS Section: 4.15.1

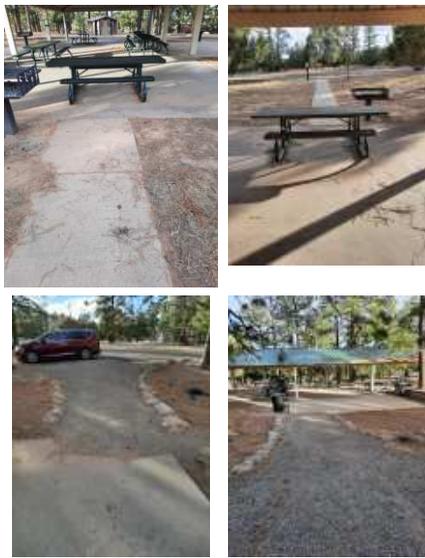
Finding Number	Area Description	Lat/Long	Finding	As Built	Recommendation	Citation	Photos	Figure
14	Park Site: Shelters/ Pavilions	[35.89615, -106.2934]	Picnic facilities shall provide outdoor recreation access routes complying with 1016 in accordance with F245.4 and 245.4 of IAC.	One entry to shelter is a gravel surface, one entry from an AR is blocked by a picnic table	Relocate picnic tables in shelter to provide unobstructed accessible entry to shelter.	2015 ABAAS Section: F245.4

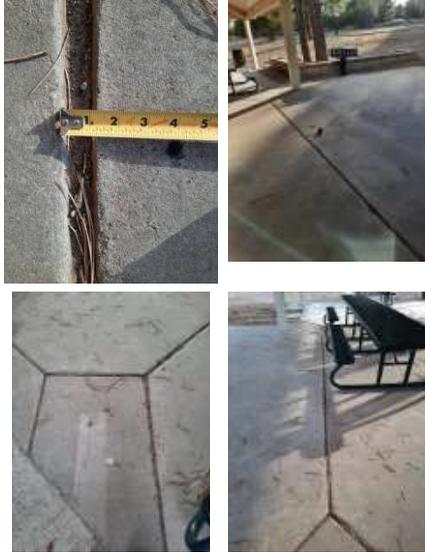
15	Park Site: Shelters/ Pavilions	[35.89615, -106.2934]	Openings in floor or ground surfaces shall not allow passage of a sphere more than 1/2 inch (13 mm) diameter except as allowed in 407.4.3, 409.4.3, 410.4, 810.5.3 and 810.10. Elongated openings shall be placed so that the long dimension is perpendicular to the dominant direction of travel. Floor or ground surface within required maneuvering clearances shall comply with 302. Changes in level are not permitted.	1.5" gaps (multiple) in central area of shelter, 1.5" gap at shelter drinking fountain	Correct or fill gap in doorway to max .5".	2010 ADAS Section: 302.3, 404.2.4.4

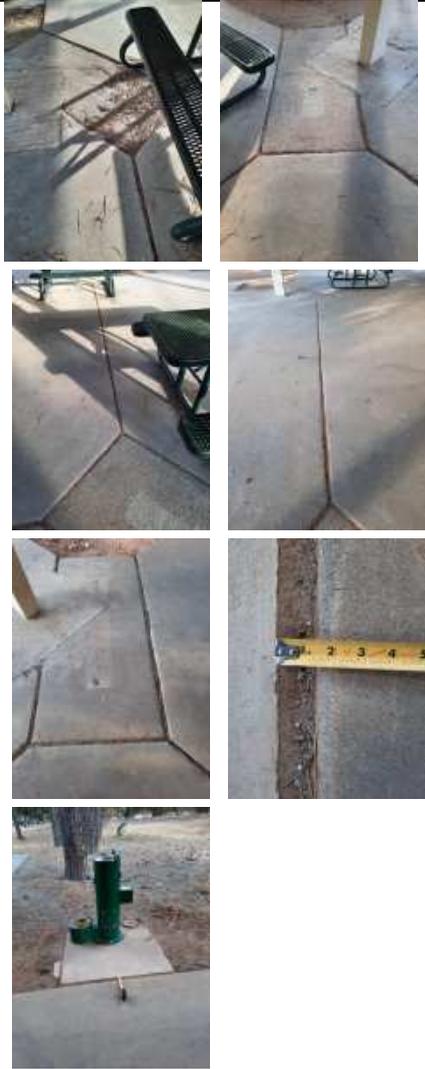
Finding Number	Area Description	Lat/Long	Finding	As Built	Recommendation	Citation	Photos	Figure
16	Park Site: Shelters/ Pavilions	[35.89615, -106.2934]	The walkway contains abrupt vertical edges and/or variations over a 1/4 inch. 1/4 inch is the maximum vertical rise. Changes in level between 1/4 inch and 1/2 inch must be beveled at 1:2 or less. Changes in level greater than 1/2 inch must be by way of a ramp.	CIL of 1"	Repair, bevel or ramp CIL along AR.	2010 ADAS Section: 303.3, 303.2 1991 ADAS Section: 4.5.2

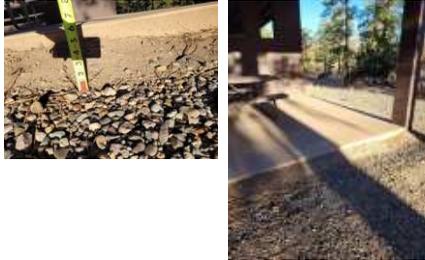
Finding Number	Area Description	Lat/Long	Finding	As Built	Recommendation	Citation	Photos	Figure
21	Park Site: Shelters/ Pavilions	[35.89615, -106.2934]	The walkway contains abrupt vertical edges and/or variations over a 1/4 inch. 1/4 inch is the maximum vertical rise. Changes in level between 1/4 inch and 1/2 inch must be beveled at 1:2 or less. Changes in level greater than 1/2 inch must be by way of a ramp.	6" CIL on right side of shelter	Repair, bevel or ramp CIL along AR.	2010 ADAS Section: 303.3, 303.2 1991 ADAS Section: 4.5.2

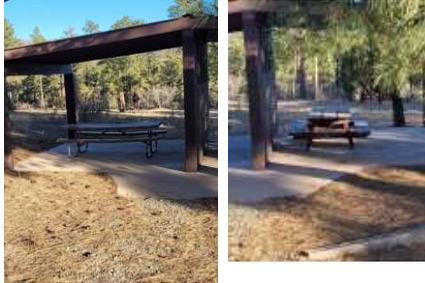
23	Park Site: Shelters/ Pavilions	[35.89615, -106.2934]	Picnic tables shall provide at least one wheelchair space for each 24 linear feet (7320 mm) of usable table surface perimeter. Wheelchair spaces shall be 30 inches (760 mm) minimum by 48 inches (1220 mm) minimum. Wheelchair spaces shall be positioned for a forward approach to the table and provide knee and toe clearance complying with 306 under the table.	0 of 2 picnic tables are of an accessible design	Replace picnic tables with ones of an accessible design as a smart practice.	2015 ABAAS Section: 1011.4.2

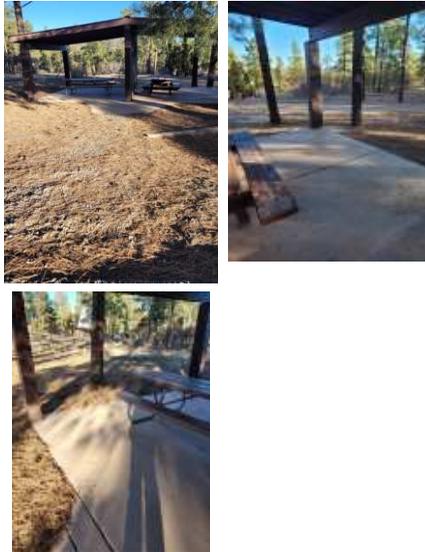
Finding Number	Area Description	Lat/Long	Finding	As Built	Recommendation	Citation	Photos	Figure
24	Park Site: Shelters/ Pavilions	[35.89615, -106.2934]	Picnic facilities shall provide outdoor recreation access routes complying with 1016 in accordance with F245.4 and 245.4 of IAC.	Lacks AR to picnic shelter	Create ORAR with crushed and compacted stone or similar outdoor material from parking or sidewalk to shelter or picnic area.	2015 ABAAS Section: F245.4

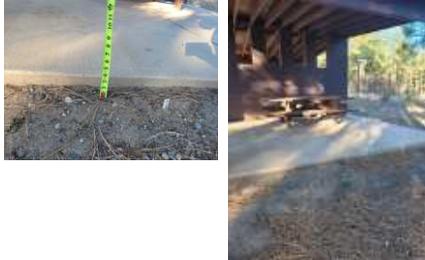
25	Park Site: Shelters/ Pavilions	[35.89615, -106.2934]	The walkway contains abrupt vertical edges and/or variations over a 1/4 inch. 1/4 inch is the maximum vertical rise. Changes in level between 1/4 inch and 1/2 inch must be beveled at 1:2 or less. Changes in level greater than 1/2 inch must be by way of a ramp.	4" CIL on side	Repair, bevel or ramp CIL along AR.	2010 ADAS Section: 303.3, 303.2 1991 ADAS Section: 4.5.2

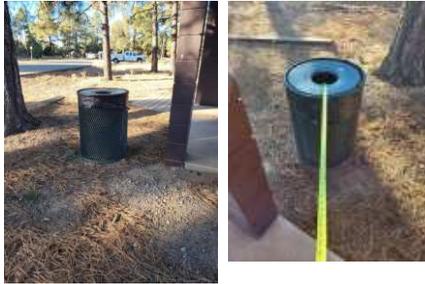
Finding Number	Area Description	Lat/Long	Finding	As Built	Recommendation	Citation	Photos	Figure
26	Park Site: Shelters/ Pavilions	[35.89615, -106.2934]	There is no accessible route to the garbage can and water spout. At least one accessible route shall connect accessible buildings, accessible facilities, accessible elements, and accessible spaces that are on the same site.	Lacks AR to garbage can and water spout	Create an accessible route with crushed stone or other outdoor material from parking or walkway to garbage can and water spout.	2015 ABAAS Section: F206.2.2 2010 ADAS Section: 206.2.2 1991 ADAS Section: 4.1.2

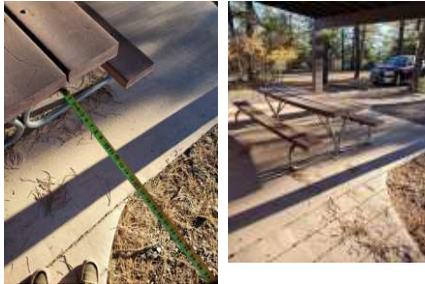
27	Park Site: Shelters/ Pavilions	[35.89615, -106.2934]	The route of travel at this location does not provide the required minimum width. The minimum clear width for sidewalks and walks is 36 inches.	Shelter closest to restroom - width reduced by table	Relocate picnic table in shelter to provide min 36" clear width in shelter and around picnic table.	2015 ABAAS Section: 403.5.1 2010 ADAS Section: 403.5.1 1991 ADAS Section: 4.2.1

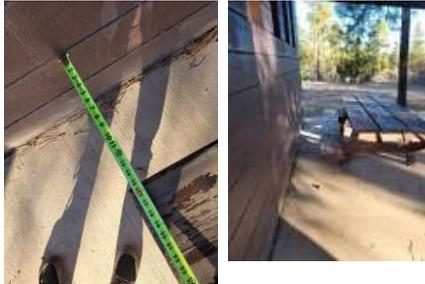
28	Park Site: Shelters/ Pavilions	[35.89615, -106.2934]	The route of travel at this location does not provide the required minimum width. The minimum clear width for sidewalks and walks is 36 inches.	Shelter closest to water tower - width reduced by table 16"	Relocate picnic table in shelter to provide min 36" clear width in shelter and around picnic table.	2015 ABAAS Section: 403.5.1 2010 ADAS Section: 403.5.1 1991 ADAS Section: 4.2.1

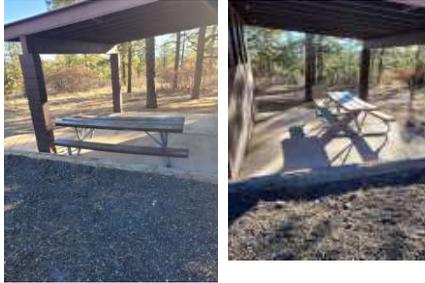
Finding Number	Area Description	Lat/Long	Finding	As Built	Recommendation	Citation	Photos	Figure
29	Park Site: Shelters/ Pavilions	[35.89615, -106.2934]	Picnic tables shall provide at least one wheelchair space for each 24 linear feet (7320 mm) of usable table surface perimeter. Wheelchair spaces shall be 30 inches (760 mm) minimum by 48 inches (1220 mm) minimum. Wheelchair spaces shall be positioned for a forward approach to the table and provide knee and toe clearance complying with 306 under the table	0 of 2 tables are of an accessible design	Replace picnic tables with ones of an accessible design as a smart practice.	2015 ABAAS Section: 1011.4.2

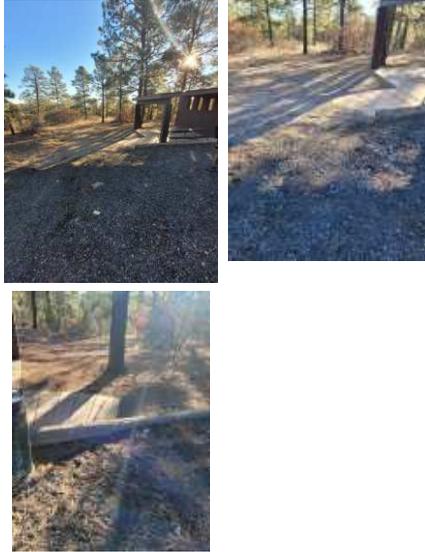
30	Park Site: Shelters/ Pavilions	[35.89615, -106.2934]	Picnic facilities shall provide outdoor recreation access routes complying with 1016 in accordance with F245.4 and 245.4 of IAC	Lacks AR to picnic shelter at far end of park	Create ORAR with crushed and compacted stone or similar outdoor material from parking or sidewalk to shelter or picnic area.	2015 ABAAS Section: F245.4

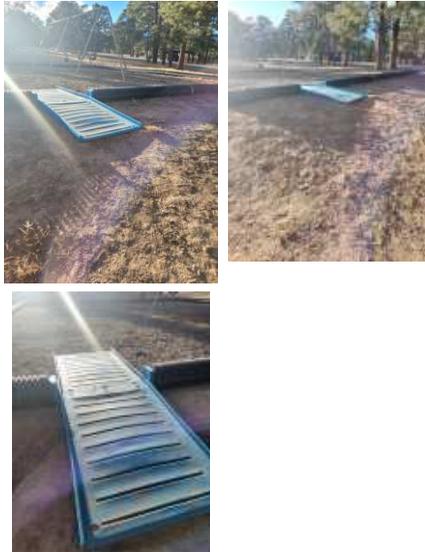
Finding Number	Area Description	Lat/Long	Finding	As Built	Recommendation	Citation	Photos	Figure
32	Playground: Play Area	[35.89615, -106.2934]	There is no accessible route to the play area. Accessible routes serving play areas shall comply with Chapter 4 and 1008.2 and shall be permitted to use the exceptions in 1008.2.1 through 1008.2.3. Where accessible routes serve ground level play components, the vertical clearance shall be 80 inches high (2030 mm) minimum.	Lacks AR to play area	Create an AR to the play area within the site. In the alternative, leave as is and designate other play areas in the County as accessible.	2015 ABAAS Section: F206.2.2 2010 ADAS Section: 206.2.2 1991 ADAS Section: 4.1.3

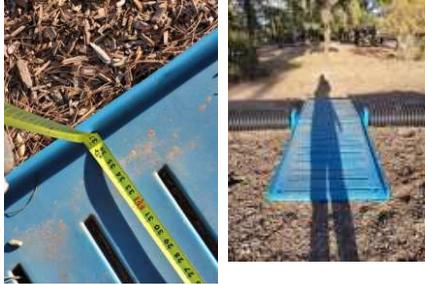
33	Playground: Play Area	[35.89615, -106.2934]	As a smart practice, play area should have a minimum 60" wide entry, free of changes in level, gaps, and slope.	Designated entry is 36" in width	Widen the designated entry to 60" width as a smart practice. In the alternative, leave as is and designate other play areas in the County as accessible.	2015 ABAAS Section: F206.1 2010 ADAS Section: 206.1

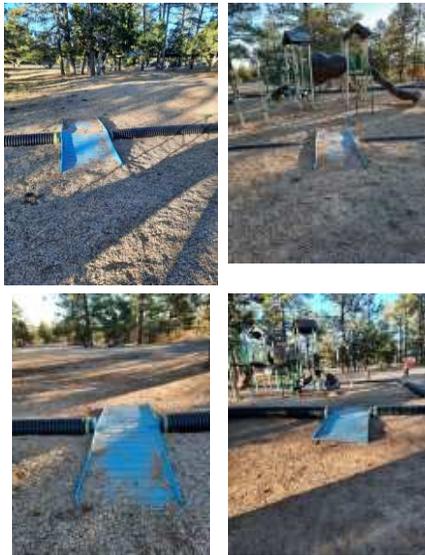
37	Playground: Play Area	[35.89615, -106.2934]	There is no accessible route to the play area. Accessible routes serving play areas shall comply with Chapter 4 and 1008.2 and shall be permitted to use the exceptions in 1008.2.1 through 1008.2.3. Where accessible routes serve ground level play components, the vertical clearance shall be 80 inches high (2030 mm) minimum.	Lacks AR to play area	Create an AR to the play area within the site. In the alternative, leave as is and designate other play areas in the County as accessible.	2015 ABAAS Section: F206.2.2 2010 ADAS Section: 206.2.2 1991 ADAS Section: 4.1.3

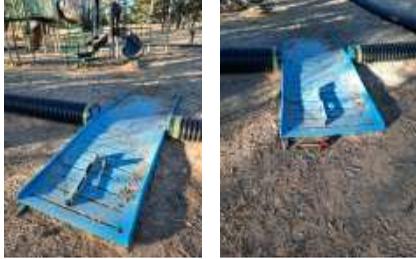
Finding Number	Area Description	Lat/Long	Finding	As Built	Recommendation	Citation	Photos	Figure
38	Playground: Play Area	[35.89615, -106.2934]	As a smart practice, play area should have a minimum 60" wide entry, free of changes in level, gaps, and slope.	Lacks compliant designated entry - 37" wide, slopes, gaps	Widen the designated entry to 60" width as a smart practice. In the alternative, leave as is and designate other play areas in the County as accessible.	2015 ABAAS Section: F206.1 2010 ADAS Section: 206.1

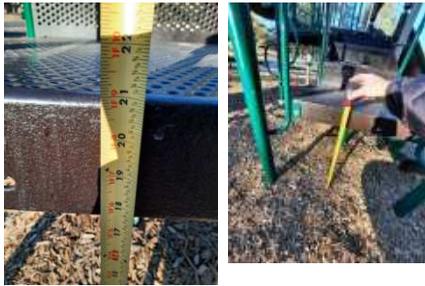
40	Playground: Play Area	[35.89615, -106.2934]	The transfer platform is not within the compliant range above the ground. The height of transfer platforms shall be 11 inches minimum and 18 inches maximum measured to the top of the surface from the ground or floor surface.	Transfer platform is 21" above surface	Lower platform on transfer system to 11" to 18" AFF, in the alternative, add and maintain surface fill level to achieve the same. In the alternative, leave as is and designate other play areas in the County as accessible.	2010 ADAS Section: 1008.3.1.2
